Manhole Inspection Summary

Manhole # S37S__028MH

Inspection ☐ Is Incomplete Rating: **3) Fair**

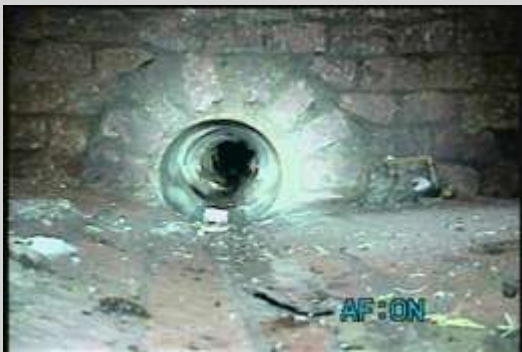
12 O'Clock Outflow

8 in. Circular Gravity Sewer
Pipe Out @ 12 O'Clock

Pipe Height: (in.) Direct
Pipe Material: **Clay** ☐ Pipe Lined
Invert Depth: **7.60** (ft.) Flow Characteristics: **Slow**
Deposits: ☐ None ☐ Mud ☐ Sludge ☒ **Debris** ☐ Grease
Silt Depth: **1** (in.) Deposits Extent: **Light**
Infiltration: **None** Pipe Seal Cond: **Unknown**

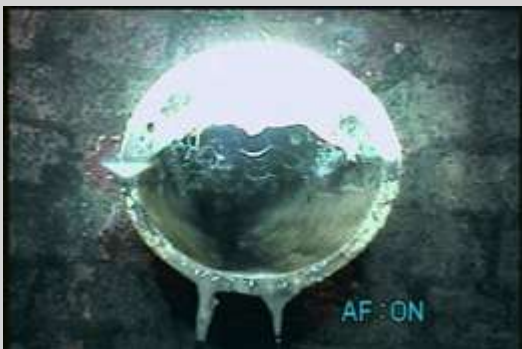
7 O'Clock Inflow

6 in. Circular Gravity Sewer
Pipe In @ 7 O'Clock

Pipe Height: (in.) Direct
Pipe Material: **Clay** ☐ Pipe Lined
Invert Depth: **6.10** (ft.) Flow Characteristics: **Slow**
Deposits: ☒ **None** ☐ Mud ☐ Sludge ☐ Debris ☐ Grease
Silt Depth: (in.) Deposits Extent:
Infiltration: **None** Pipe Seal Cond: **Unknown**
